An integrated approach for indoor microclimate diagnosis of heritage and museum buildings : the main exhibition hall of Vleeshuis museum in Antwerp

<b>Manuscript number</b>	ENB_2017_1975_R2
<b>Title</b>	An integrated approach for Indoor microclimate diagnosis of heritage and museum buildings: the main exhibition hall of Vleeshuis museum in Antwerp
<b>Article type</b>	Full Length Article

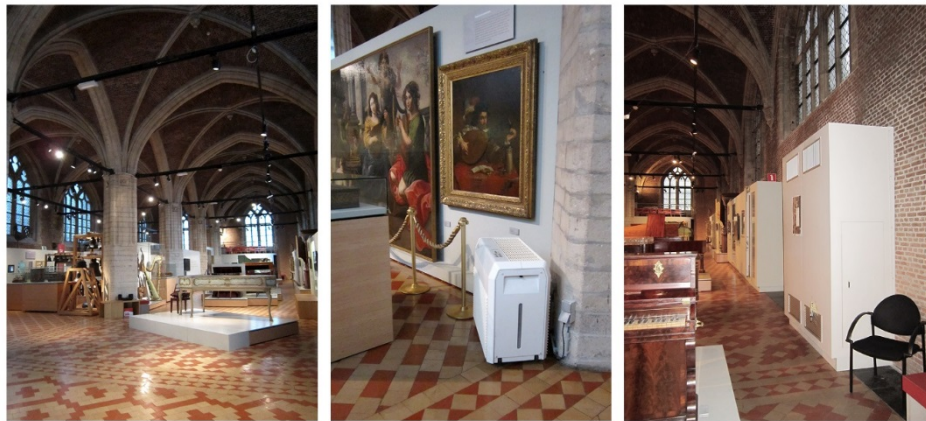
**Fig. 2.1.13.1.a-c** (from left to right); Ground floor exhibition hall of the Vleeshuis internal view (a); example of humidifier present in the exhibition hall (b); air heating and ventilation unit integrated in a closet (similar to the showcases) on the North wall (c)

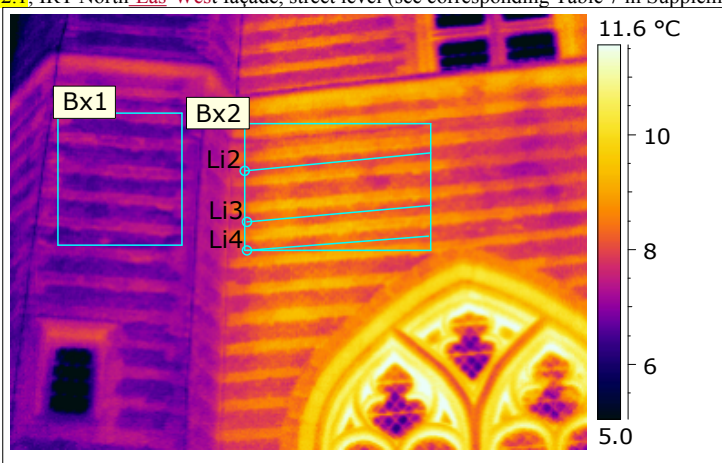
[Figure 35.2.2](#); IRT North-EasWest façade, vaults level (see corresponding Table 8 in Supplementary Data)

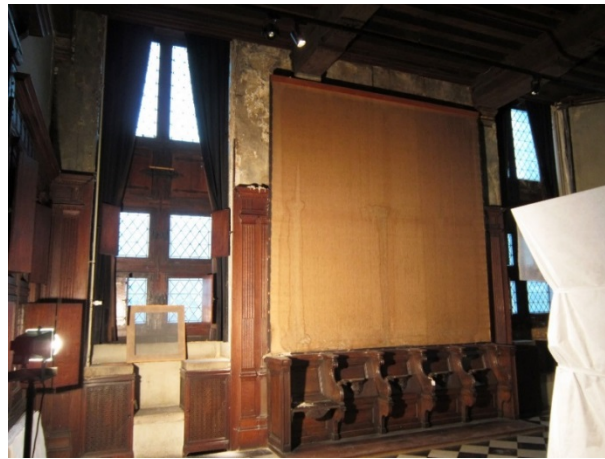
Figure 35.2.4; Room at the first floor on the North-~~East~~West corner; the damage due to moisture in the masonry is extended to the entire inner plaster surface (North façade), especially behind the textile and pews.

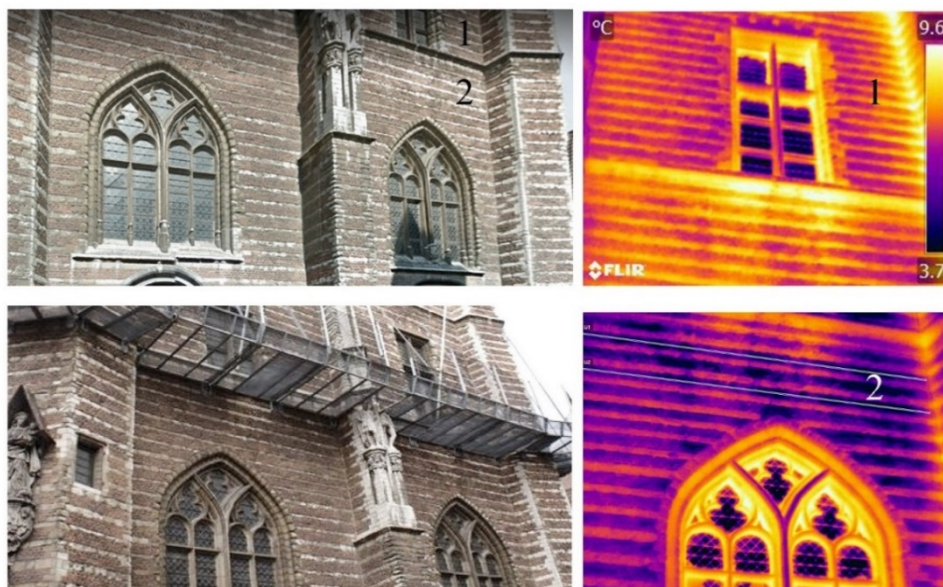
Figure 35.2.6: EastWest façade; current view (upper left) and view between 2007-2009 (lower left) with debris collection system (Vleeshuis museum archive); The tie rods anchors (detail 1) and metal plates (detail 2) of the scaffold are the infiltrative water sources respectively above and below the kerb, see upper and lower IR thermogram (on the right) for detail 1 and 2

In 2007, to secure the pedestrians from the continuous fall of stones and tiles from the building, a temporary debris collector system was installed (Fig. 35.2.6). The suspended ring scaffold system was attached to the building facades by means of tie-rods and section bars. The sections were screwed, via metal plates, to the building masonries. Because it was ineffective, the system was re installed on a higher position in 2008 and definitively removed in 2009 [34]; Figure 35.2.6 shows the building between the years 2007-2009 with the system installed.

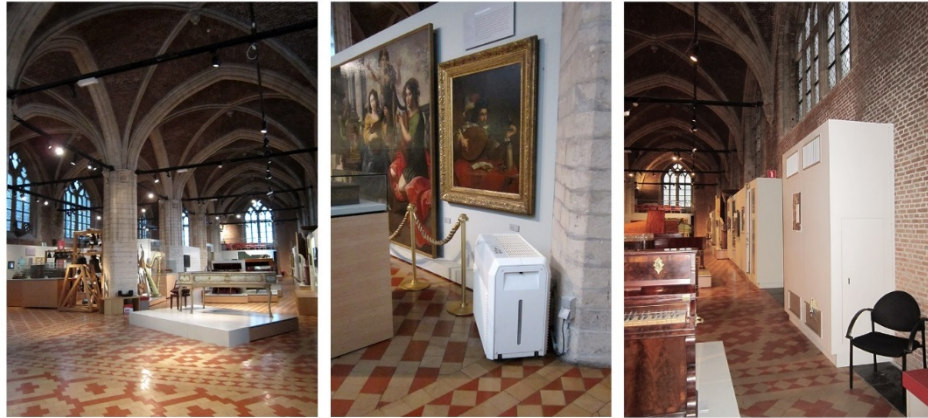
Fig. 2.1.1.a-c (from left to right); Ground floor exhibition hall of the Vleeshuis internal view (a); example of humidifier present in the exhibition hall (b); air heating and ventilation unit integrated in a closet (similar to the showcases) on the North wall (c)

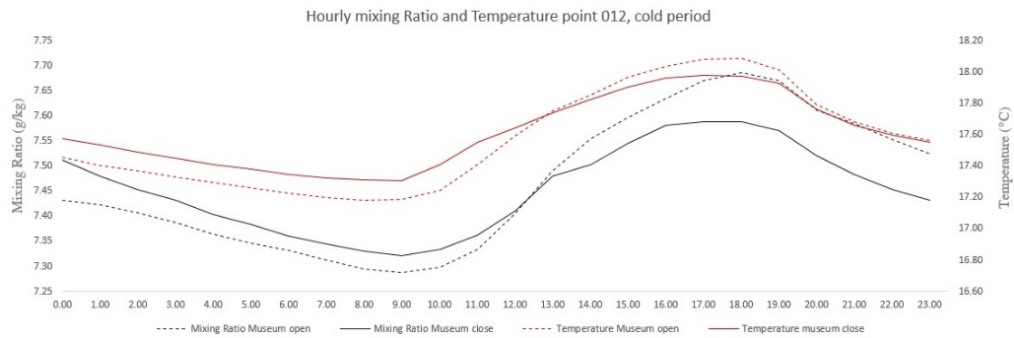
Fig. 3.1.2.2. Mean hourly indoor mixing ratio and temperature during closing and opening hours of the museum (opening 10am-5pm); cold period (February, November, December 2014 and January 2015); point 012

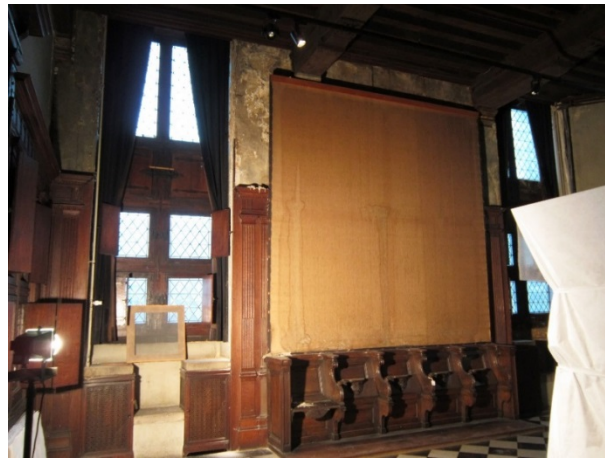
Figure 3.2.4; Room at the first floor on the North-East corner; the damage due to moisture in the masonry is extended to the entire inner plaster surface (North façade), especially behind the textile and pews.

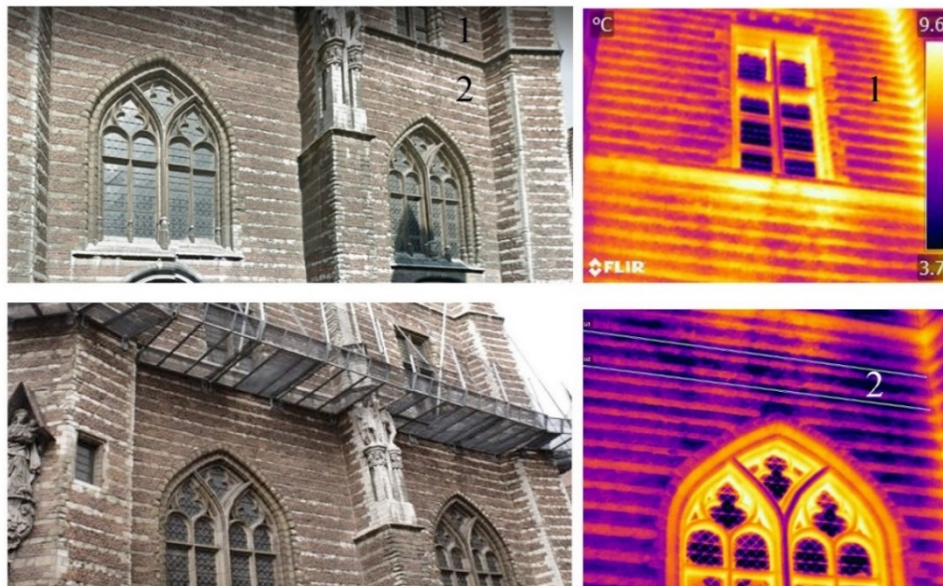
Figure 3.2.6; East façade; current view (upper left) and view between 2007-2009 (lower left) with debris collection system (Vleeshuis museum archive); The tie rods anchors (detail 1) and metal plates (detail 2) of the scaffold are the infiltrative water sources respectively above and below the kerb, see upper and lower IR thermogram (on the right) for detail 1 and 2

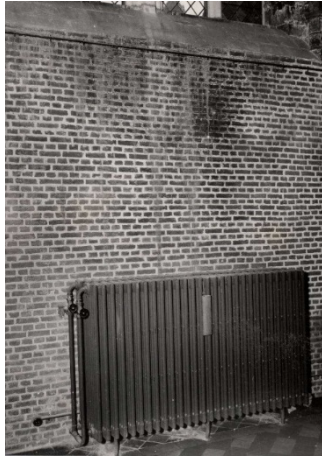
Figure 1; 1964; water infiltration through the stained glasses; source Vleeshuis archive

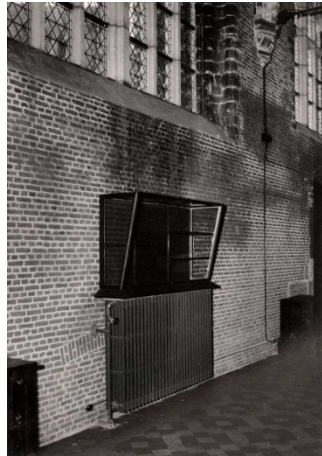
Figure 2; 1964; water infiltration through the stained glasses and soiled masonry; source Vleeshuis archive

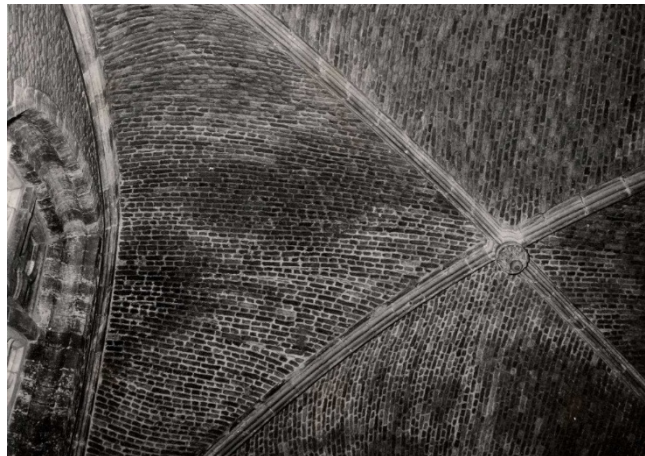
Figure 3; 1964; water infiltration through the vault; source Vleeshuis archive

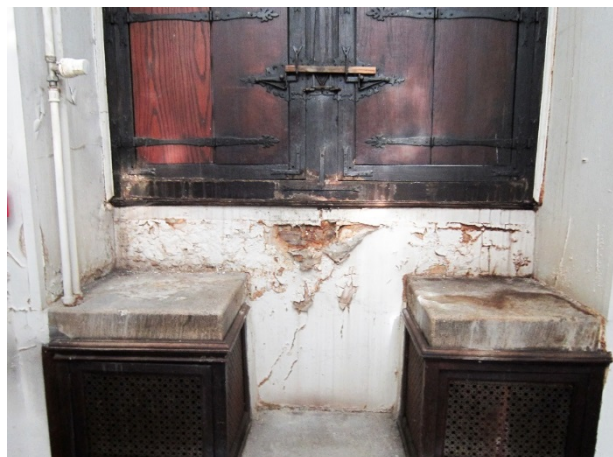
Fig. 12; First floor level; typical localisation of radiators under a window on the first floor of the building. The wall is deteriorated due to inwards water infiltration and forced evaporation (accelerated by the heating system)
