Hygrothermal performance evaluation of traditional brick masonry in historic buildings

Giovanni Litti* (1)
Somayeh Khoshdel (1)
Amaryllis Audenaert (1)(2)
Johan Braet (2)

This study suggests an indirect methodology for evaluating the masonry thermal performance and its local variations caused by the heterogeneous distribution of moisture. The methodology has been applied in Vleeshuis Museum in Antwerp (Belgium).

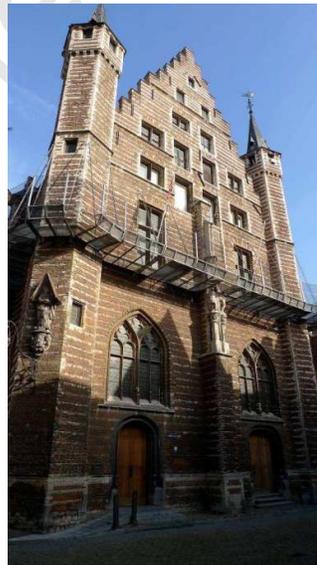
Image 7.1; Vleeshuis museum in Antwerp

The monitored building, the music instruments museum of Antwerp, is a typical medieval Flemish slaughterhouse (Image 7.1). The importance of this outstanding building is not given only by the collection in it contained, but by the building historical significance itself. Although the use destination has changed across the centuries, it is still possible to observe the original architectonic volume.

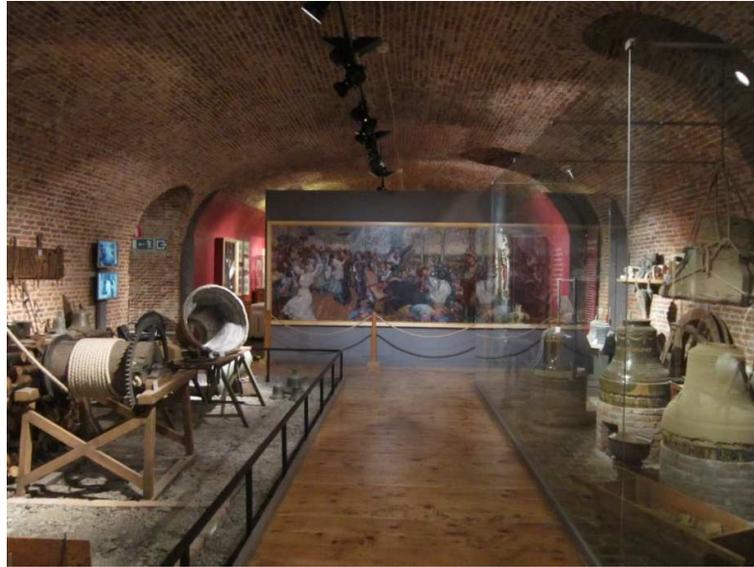
Image 7.2; Vleeshuis museum, basement level; former slaughter space and actual exhibition space

The building was built ensuring independent uses: the slaughter space, the market space, the residential and storage spaces. These functions were typologically defined by specific architectural features and indoor performance requirements [63]. The slaughter space (Image 7.2) was built in the cellar according to the need of blood and waste disposal; the covered market, where the products were sold, is localised at ground floor (Image 7.3), while spaces for receptions and storage were housed at the upper floors. The study was conducted in one of these latter spaces (Image 7.4). The vertical distribution through the levels is ensured by five towers: one on each building corner and one extra tower on the south façade. Currently the exhibition of musical instruments and paintings related to the musical tradition of the city is at the ground level and in the cellar. The rest of the building is partially used as office and storage.

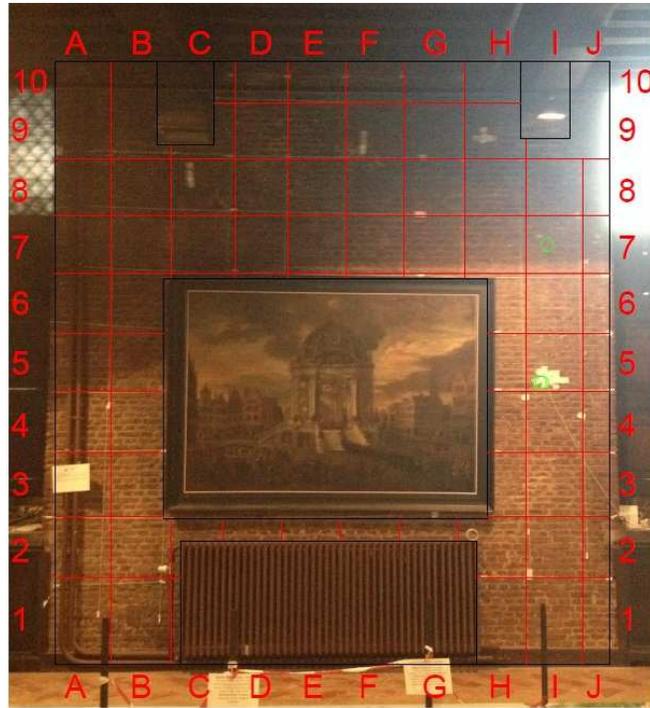
*Image 7.2.2; Wall section 2 grid surface (50*50 cm), grid distance from the floor level 72cm; the green points indicate the measurement points as described in Table 8.1.1*
