Characterization of corrosion products on carbon steel using hyperspectral imaging in Short-Wave Infrared (SWIR)

Workshop on Hyperspectral Image and Signal Processing, Evolution in Remote Sensing : [proceedings] - ISSN 2158-6268 - IEEE, 2022, p. 1-4 Full text (Publisher's DOI): https://doi.org/10.1109/WHISPERS56178.2022.9955125

CHARACTERIZATION OF CORROSION PRODUCTS ON CARBON STEEL USING HYPERSPECTRAL IMAGING IN SHORT-WAVE INFRARED (SWIR)

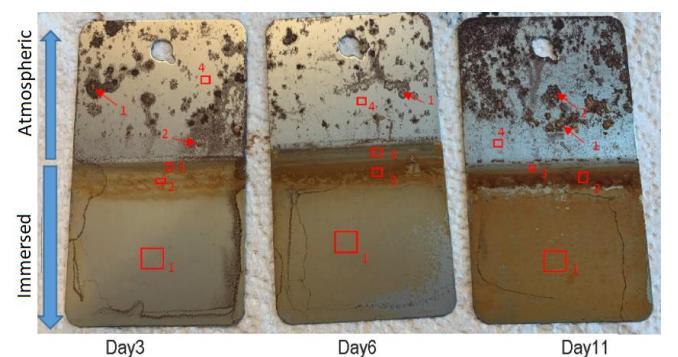
Figure 1. Selected regions for SEM-EDX analysis

In this study, 5 carbon steel samples were immersed in water (5 wt% CaCl₂) for different durations from 2 hours, to 1, 3, 6, and 11 days. The submerged zone and atmospheric zone (outside water) of the samples are shown in Figure 1 with selected regions for SEM-EDX analysis. These regions are selected based on their locations and appearance on the samples; Rec1 is selected rectangle from the submerged zone of the samples where a uniform corrosion layer is formed, Rec2 is selected on the reddish boundary line between the submerged and the atmospheric zones (directly above the submerged zone), Rec3 is selected on the greenish boundary line closer to the atmospheric zone, Rec4 is selected in the blank steel region (without corrosion), Arrow1 and Arrow2 denote yellowish and dark corrosion spots in the atmospheric zones respectively. It should be noted that the SEM-EDX analysis has only been conducted on samples of Day 3, Day 6, and Day 11. However, hyperspectral images are taken from all the samples (RGB image of all samples are shown in Figure 2). Because there was a time difference between the SEM analysis and hyperspectral scanning (HS scanning was performed 2 weeks after SEM analysis) more corrosions -had grown on the surface of the samples at the time of HS scanning (Day11 in Fig.1 vs. Day 11 in Fig.2).

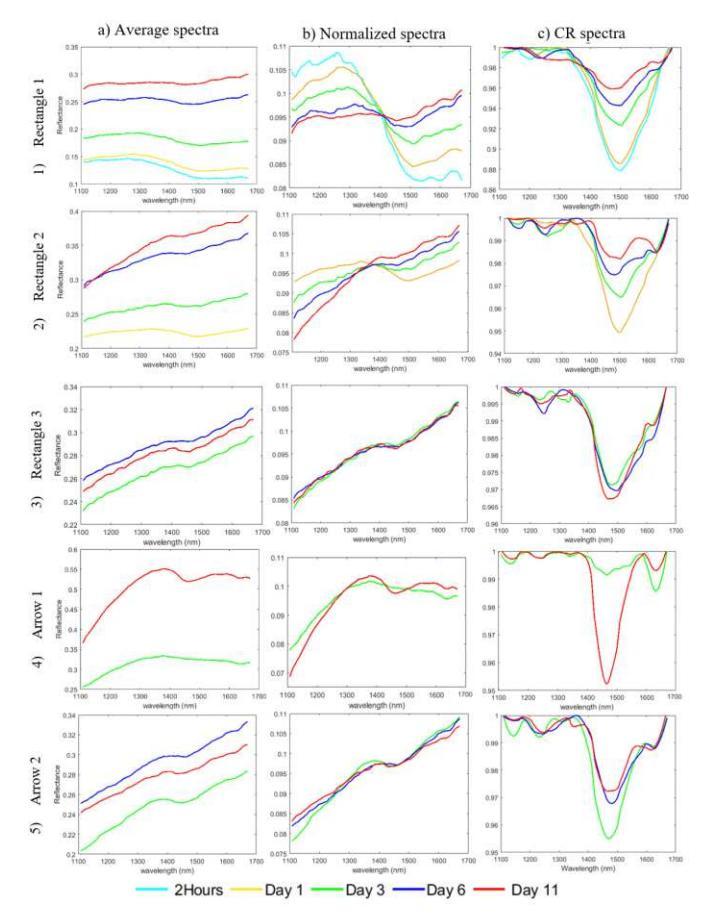
Figure 3. Spectral behavior of different regions in the SWIR range

The spectra of Rec1 and Rec2 increase in reflectance values with increasing immersion time, in the entire wavelength range. However, in Rec1 and Rec2, a gradual increase in reflectance values is observed after 1,400 nm and after 1,370 nm, respectively, which is more apparent in samples with longer immersion time (Fig.3-1a and Fig.3-2 a). A similar pattern is observed in normalized spectra when samples are longer immersed in water in both Rec1 and Rec2 regions (Fig.3-1b and Fig.3-2b). However, the normalized spectra of Rec3 do not change with increasing

immersion time (Fig.3-3b). When continuum removal (CR) pretreatment is applied to the spectra, two absorption features around 1,200 nm and 1,500 nm are observed in Rec1, Rec2, and Rec3 (Fig.3.1c, Fig.3.2c, Fig.3.3c). The size of the absorption features at 1,500 nm reduces with increasing immersion time, except in Rec3.

As with corrosion in the immersed zone, the reflectance values of corrosions in the atmospheric zone; in Arrow1 and Arrow2, also increase with immersion time, except at Arrow2 of Day11 (Fig.3-4a and Fig.3-5a). However, this is merely a scaling effect because after normalization, the spectrum of Arrow2 in Day11 becomes closer to the spectra of Day3 and Day6 (Fig.3-5b). The average spectrum of Arrow1 in Day11 contains an absorption feature at 1470 nm (Fig.3-4a). This feature was not observed as clearly in the average spectra of other regions and it is relatively large when plotting the CR spectra (Fig.3-4c).

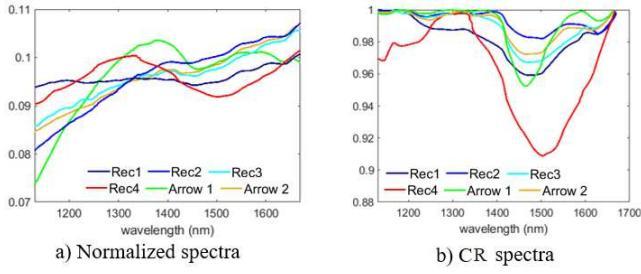
Figure 4. Spectral behavior of different regions in sample Day11

In Fig. 4, the average, normalized and continuum removed spectra of the 6 different regions in sample Day11 are plotted against each other. The normalized spectra of different regions are distinctive, except for the spectra of

Rec3 and Arrow2 which are very similar (Fig.4a). The CR spectra are also quite distinctive (Fig.4b).

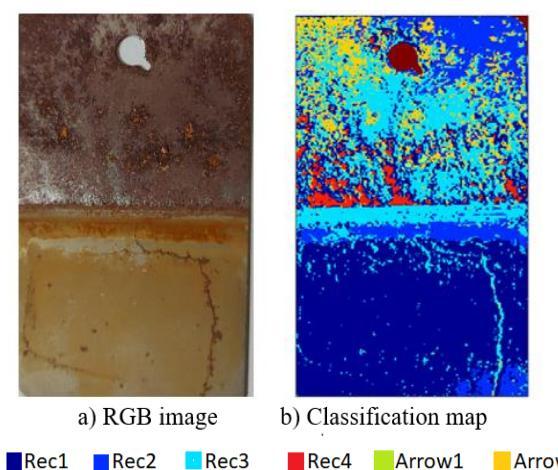
Figure 5. RGB image and SVM classification map of sample Day11

Each of the regions in Sample Day11 (Rec1, Rec2, Rec3, Rec4, Arrow1, and Arrow2) is considered as a different material class. A SVM classification model was built using one third of the pixels in each region as training data and keeping the other two third for testing. The model was then applied to the entire sample Day11 (Fig.5). Because full-surface ground truth was not available, the classification results on the sample were only assessed qualitatively. In the submerged zone, the different corrosion classes (Rec1, Rec2, Rec3) are quite well distinguishable (Fig.5b). The SWIR image leads to good classification results for Arrow 1, Arrow2 and Rec4 in the atmospheric zone as well.
